## **R22 SAFETY ALERT**

Issued: 22 December 2016

### **A016-6 MAIN ROTOR BLADE CRACK**

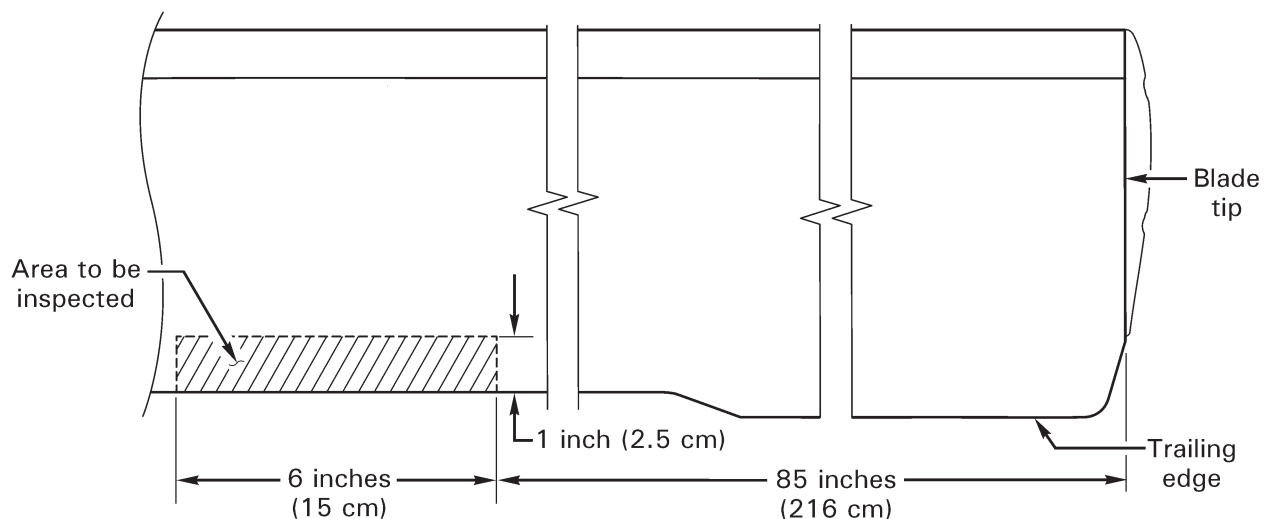
**A016-6 MAIN ROTOR BLADE**  
(View looking down on blade)

RHC has received a report of a cracked A016-6 main rotor blade on an R22 used for cattle mustering. The crack began at the trailing edge approximately 90 inches inboard of blade tip. Careful visual inspection of this area during preflight will provide early detection and prevent a catastrophic failure.

During daily preflight inspection, visually inspect the trailing edge in the area shown on upper and lower surfaces of blade (a stepladder may be necessary). A felt-tip marker can be used to outline areas to be inspected. Verify no indication of corrosion, paint blistering, nicks, scratches, or other damage which may initiate a crack. If any damage is detected have blade repaired prior to further flight per R22 Maintenance Manual § 9.140. Chromated epoxy primer is recommended for refinishing.

If unusual rotor system vibration is detected in flight, land immediately and have blades examined by a qualified technician.
