Safety Investigation Report

Ref.:
AAIU-2017-54

**ACCIDENT
ROBINSON R44
AT EBNM AERODROME
ON 8 OCTOBER 2017**

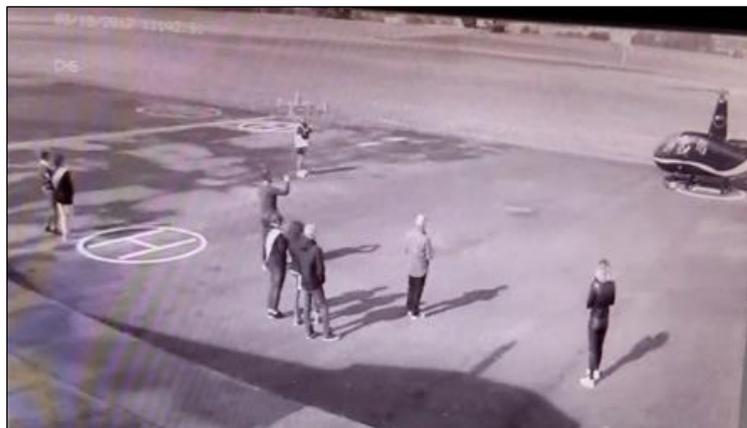
The group of people accompanying the winners and organizers of the beauty contest – 9 people in total - gathered outside to watch the take-off and take pictures and videos. They were standing between the hangars and the helicopter, at a short distance.

Figure 1: people gathered near the helicopter ready for take-off

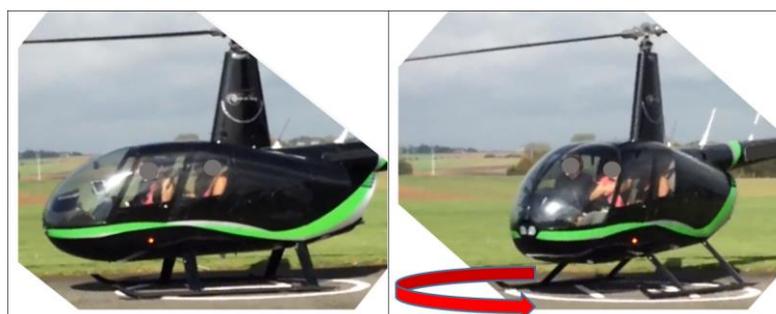
About 12 seconds after the landing of the other helicopter, when initiating lift off, the helicopter was suddenly taken in a violent counter-clockwise rotation. The pilot stated that he had the impression that his actions on the pedals were ineffective just as if the tail rotor controls were failing. A video shows the helicopter still on the ground turning about 45° to the left in about one second just before lift-off.

Figure 2: Stills from the smartphone footage showing the helicopter ready for take-off (left) and the helicopter having turned 45° to the left one second later (right)

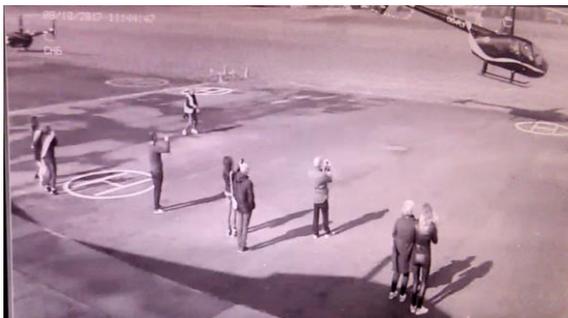
Figure 3 : 2 seconds after lift-off – 180° CC turn

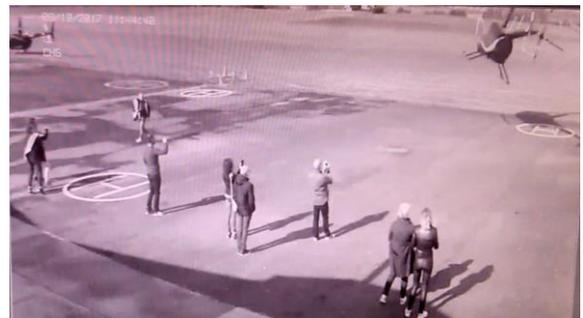
Figure 4 : 3 seconds after lift-off – 300° CC turn

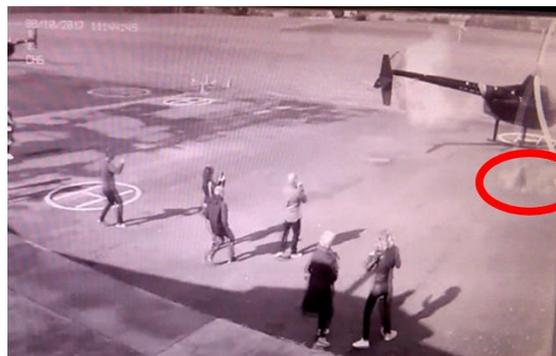
Figure 5 : Rotor blade hits the ground

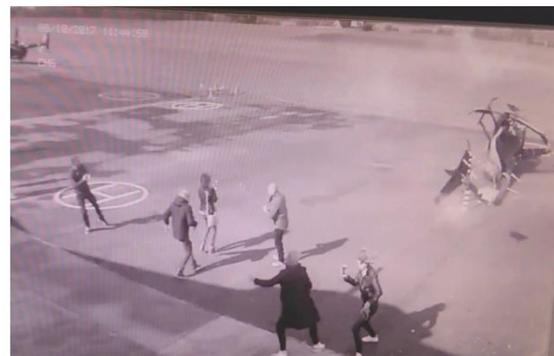
Figure 6 : Final rest after 5 seconds (1 turn $\frac{3}{4}$)

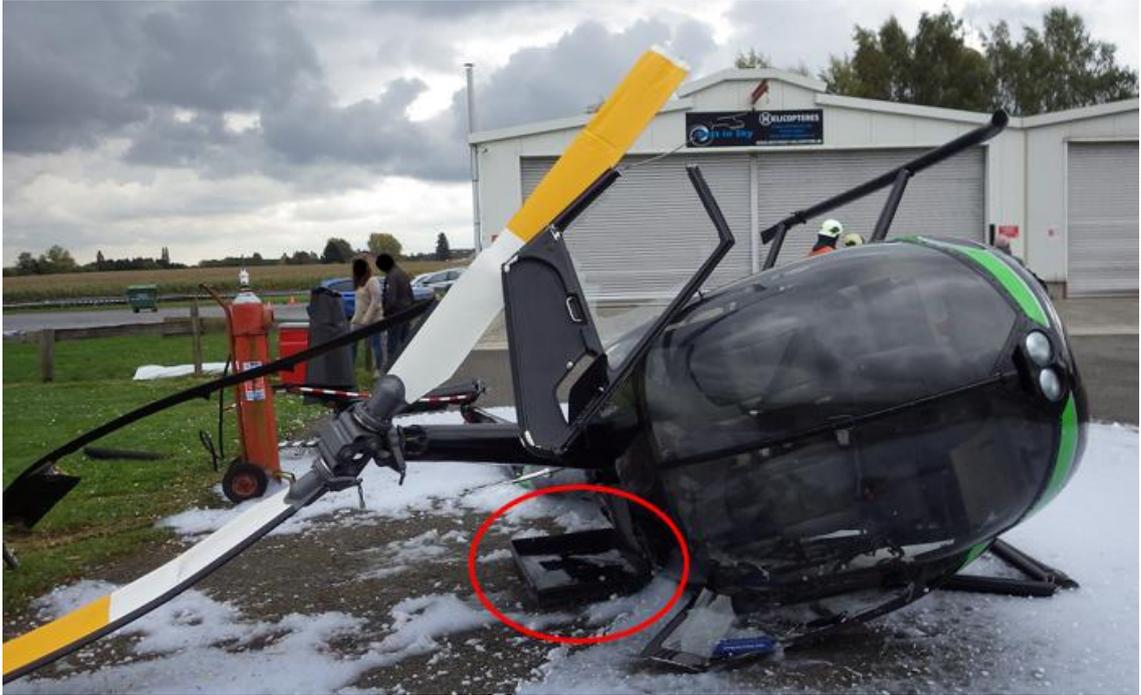
Although there was a small continuous fuel leak coming from the area located above the auxiliary (right) fuel tank, the helicopter did not catch fire. A plastic container was placed to collect the fuel leak.

Figure 7: Wreckage with a collecting pan avoiding the fuel leak to flow on the ground

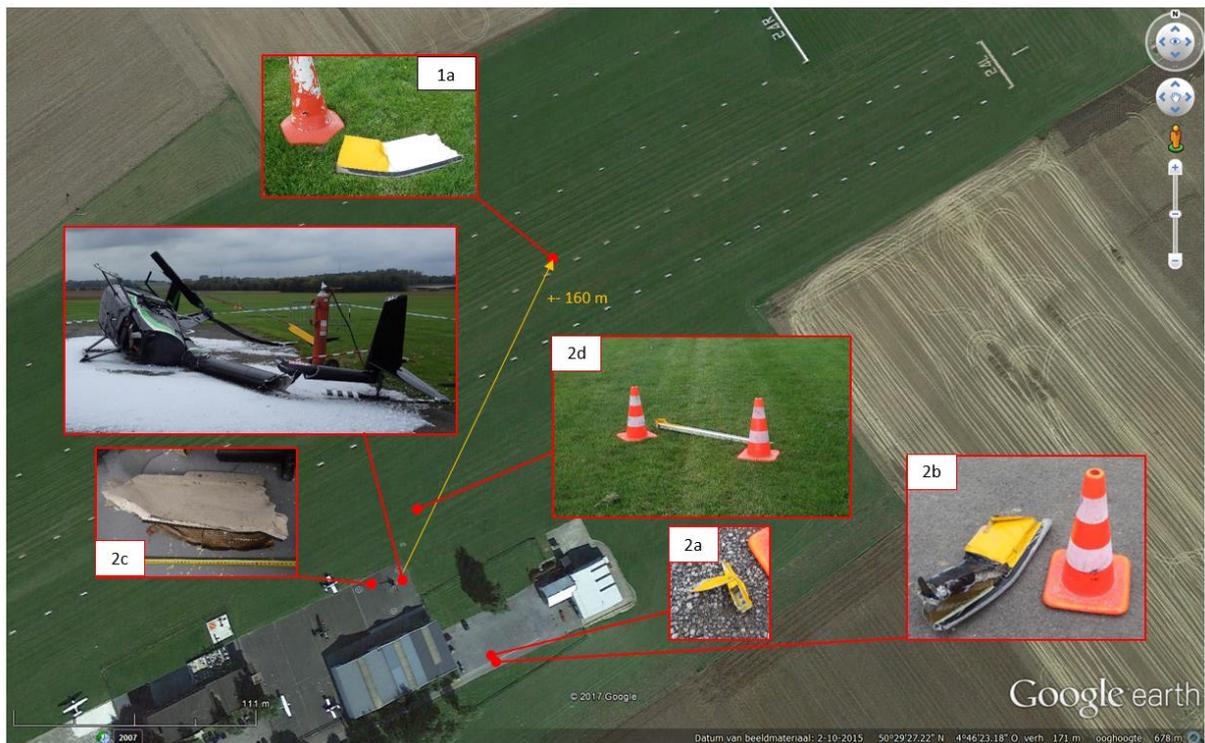
- The helicopter started to rotate counter clockwise with both skids on the ground;
- The helicopter lifted off and made a 360-degree turn;
- The helicopter hit the ground violently with the right-hand skid;
- The helicopter turned further counter-clockwise with a bank to the right;
- The tail struck the ground with its RH side (tail rotor up). The tail and the tail rotor drive shaft broke off;
- One main rotor blade tip hit the ground with high energy. A piece of the blade (1a) was torn off and was projected horizontally towards the runway, more than 160 m away;
- The other blade hit the ground with lower energy and was subsequently bent. Several pieces of this blade (2a, 2b, 2c, 2d) broke off and were also projected. They fell close to the main wreckage.

Figure 10: Aerial view showing the scattered parts of the helicopter

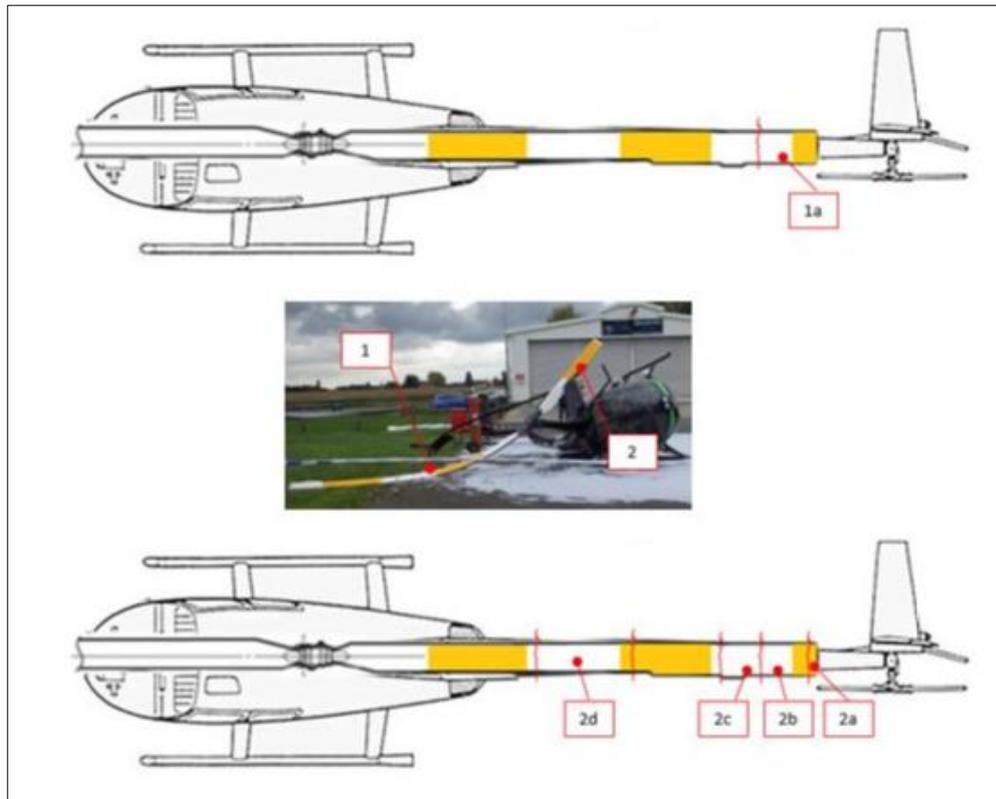
Figure 11 : Sketch identifying the different severed parts of the main rotor blades

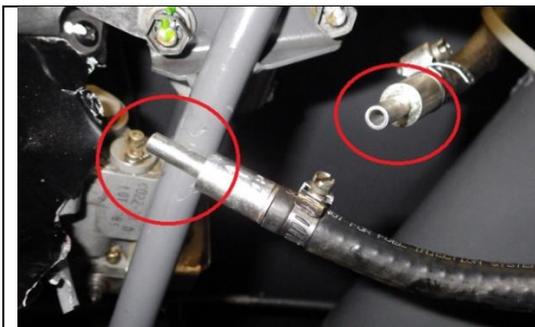
The interconnecting vent line, made of a rubber tubing forming a vertical loop, connecting together the left (main) to the right (auxiliary) fuel tanks, was found severed at about 6 cm from the connection to the left fuel tank. The tie-wrap holding the loop of the tubing in up position on a rib of the mast fairing was also elongated and cut. In the same area, the vent line of each fuel tank was found disconnected at the vent rollover valve.

Figure 12 : Disconnected fuel vent lines.

Witnesses stated that the fuel leak did not originate from the tanks or from the tank caps and the examination of both rollover valves showed that their disconnection occurred at the correct location. It was also determined that these rollover valves were in good condition and that they properly blocked the vent to minimize fuel spillage.

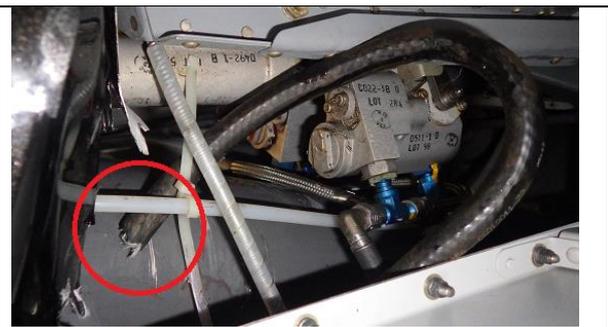
Figure 13 : Severed interconnecting vent line

As the helicopter was lying on its right side, the ruptured vent line interconnecting the fuel tanks was located at a lower height than the fuel level in the tank. This caused the fuel spillage observed when the helicopter was lying on its right side.

It is recommended that Robinson Helicopter Company improves the design of the vent line interconnecting the fuel tanks to further mitigate the risk of fuel leak in case of survivable accident, by reviewing the routing of the vent line, its length and the fixture of the vertical loop.

Based on the information we received shortly after the accident, the fuel vent hose installation was revised to use a lighter tie-wrap (MS3367-4-9 replaced MS3367-5-9, revised). The blueprint revision was approved on 17 November 2017, it was likely 2-3 weeks later when the assembly line began installing the -4-9 ty-raps on all new production and overhaul aircraft.

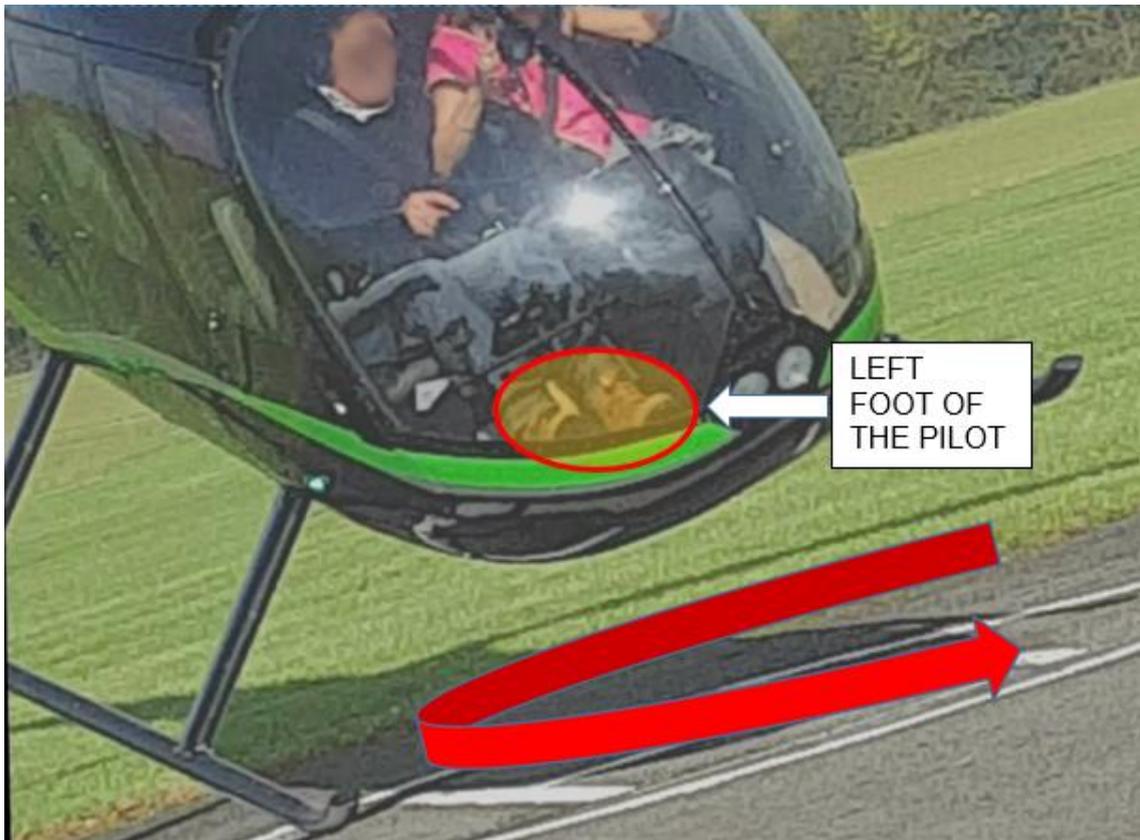
Figure 14 : The helicopter after $\frac{1}{4}$ counter-clockwise turn, showing that the pilot is pushing on the left pedal

When the helicopter became light on the skids, just before the lift off, with the two skids still touching the ground, it started to turn rapidly 45 degrees counter-clockwise. A still of the video footage, just after lift-off when the helicopter reached a 90 degrees turn, clearly shows the left foot of the pilot pushing on the left yaw pedal.

The pilot had the impression that his actions on the pedals were ineffective to stop the helicopter rotation. He likely did not realize the helicopter was rotating left instead of right.

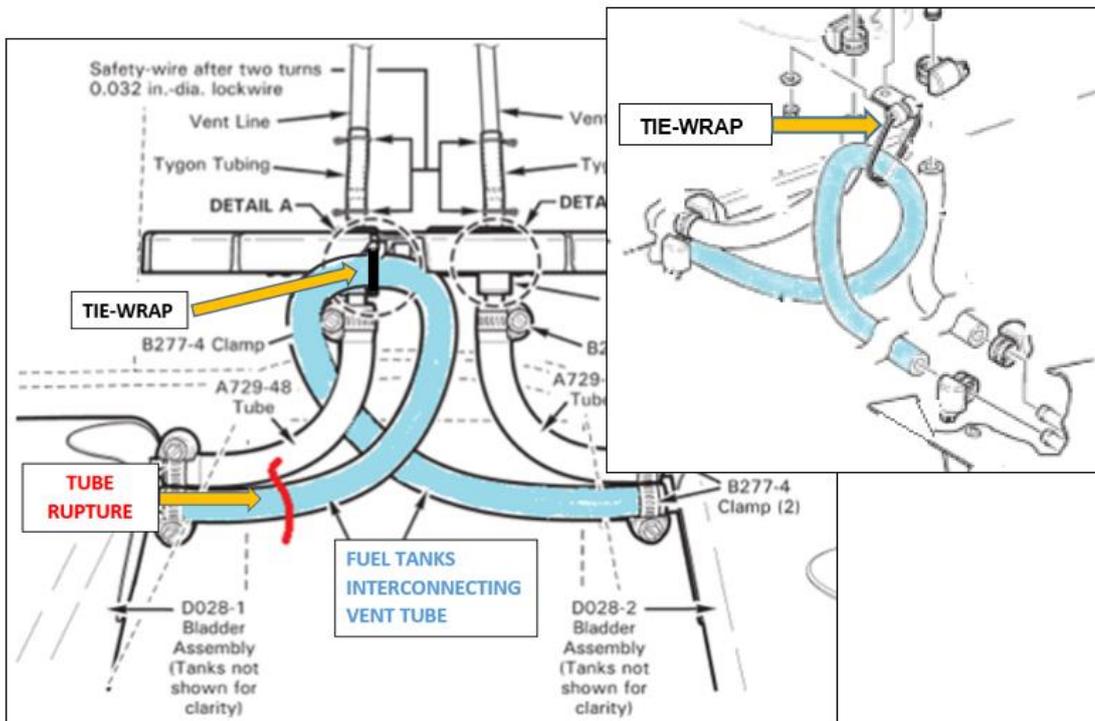
Figure 17 : Drawing of the interconnecting vent line and its tie-wrap (view looking aft)

Examination of the rubber vent line and the tie-wrap holding it upright to the rotor mast determined they failed upon impact.

By design, in case of deformation of the surrounding structure, the tie-wrap should fail first in order to release the vertical loop of the rubber vent line. This would give the rubber vent line a better freedom of movement and allow for a reduced risk of rupture.

However, in this case, both the tie-wrap and the rubber vent line ruptured. This suggests that both ruptures occurred exactly at the same time because the strength of the tie-wrap was equivalent to the rubber vent line strength.

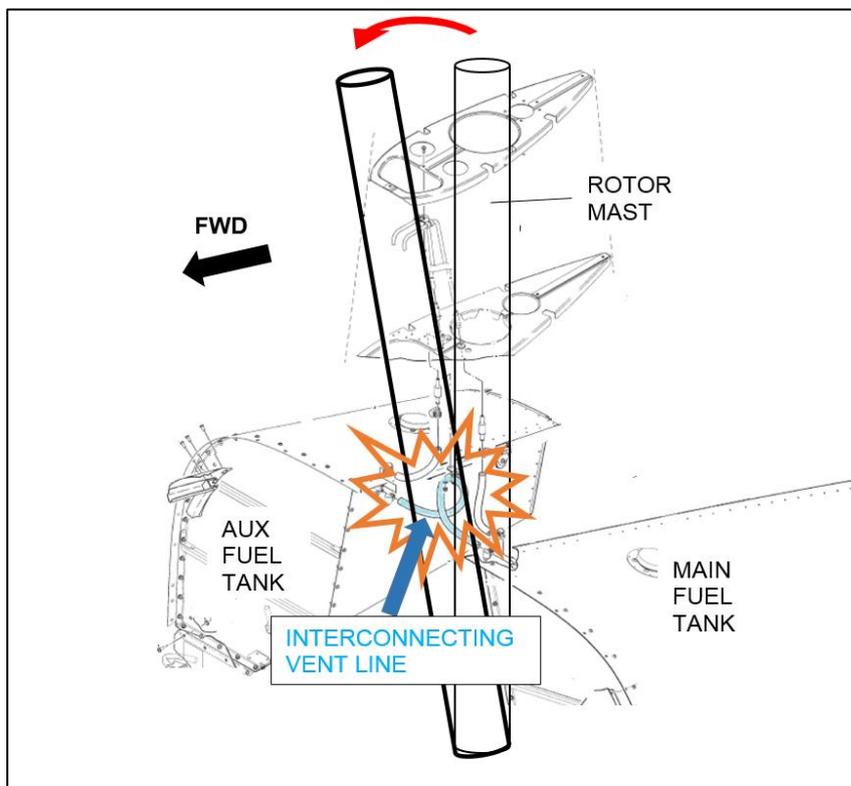
Figure 18 : Rocking of the main rotor mast causing the rupture of the rubber line.

Both the rubber vent line and the tie-wrap ruptured because they were pulled away by the deformation of the surrounding structure caused by the rocking movement (moving in the lateral and longitudinal direction) of the rotor mast at impact.
