Airworthiness Directives; Robinson Helicopter Company Helicopters

ACTION: Notice of proposed rulemaking (NPRM).

Robinson Helicopter Company: Docket No. FAA-2023-2232; Project Identifier AD-2023-00943-R.

This AD was prompted by reports of helicopters losing a TRB tip cap. The FAA is issuing this AD to detect and prevent TRB tip cap failures. The unsafe condition, if not addressed, could result in increased vibrations, reduced controllability, and subsequent loss of control of the helicopter.

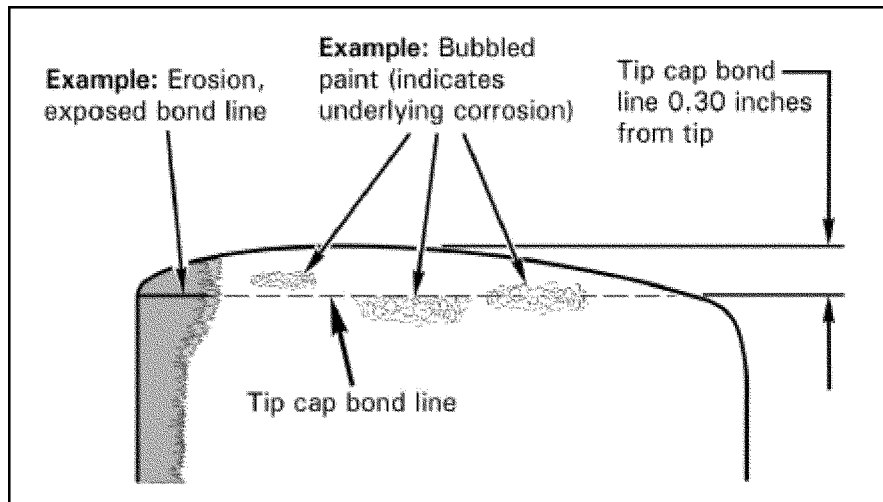
Figure 1 to Paragraph (g)(1)—TRB Tip Cap Check/Inspection

(1) Within 10 hours time-in-service (TIS) after the effective date of this AD and thereafter before the first flight of each day, visually check each TRB tip cap area (at and adjacent to the tip cap bond line on each surface and edge of the TRB) for an exposed tip cap bond line or bubbled paint, as depicted in Figure 1 of paragraph (g)(1) of this AD. These items may indicate evidence of corrosion. The owner/operator (pilot) holding at least a private pilot certificate may accomplish this TRB tip cap check and must enter compliance with this paragraph of the AD into the helicopter maintenance records in accordance with 14 CFR 43.9(a) and 91.417(a)(2)(v). The record must be maintained as required by 14 CFR 91.417, 121.380, or 135.439.

(2) Within 100 hours TIS or during the next 100 hour or annual inspection after the effective date of this AD, whichever occurs first, and thereafter at intervals not to exceed 100 hours TIS or during the next 100 hour or annual inspection, whichever occurs first, visually inspect each TRB tip cap area (at and adjacent to the tip cap bond line on each surface and edge of the TRB) for evidence of corrosion, which may be indicated by an exposed tip cap bond line or bubbled paint, as depicted in Figure 1 of paragraph (g)(1) of this AD.

(3) As a result of the actions required by either paragraph (g)(1) or (2) of this AD, if there is evidence of corrosion, an exposed tip cap bond line, or bubbled paint, before further flight, remove all of the corrosion.

(4) Within 10 months of the effective date of this AD, remove all TRBs identified in paragraph (c) of this AD from service.
