GASIL

General Aviation Safety Information Leaflet

Issue no. 10 of 2012

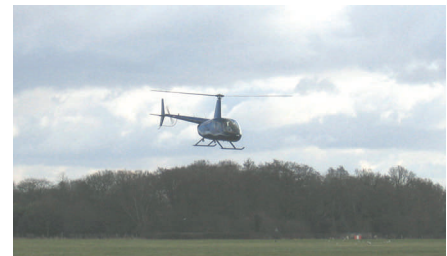
Helicopter hot and high

The BEA (French AAIB) recently published an accident report concerning an R44. It seems the pilot was attempting to land in a mountainous area, but his planned landing site was considered unsuitable and he decided to change to one a short distance away. While approaching that site at a height of a few feet and at very low speed, the rotor was unable to provide sufficient power to maintain the approach path. The helicopter's skid contacted the ground, causing it to turn and contact the ground heavily before catching fire.

Taking into account the site elevation and the temperature, the investigation suggests that while the aircraft was in ground effect there was more than adequate power available to stay airborne at the low airspeed. However, once some of that ground effect was lost, possibly due to the sloping terrain, or to a gusting wind, the power available was insufficient to maintain level flight.

Conditions in mountainous or even hilly terrain can change rapidly. To operate safely in such terrain requires considerable knowledge, not only of orographic meteorology but also of our aircraft's performance. We must also be conscious of the human factors which may lead us to either forget or disregard that fact.

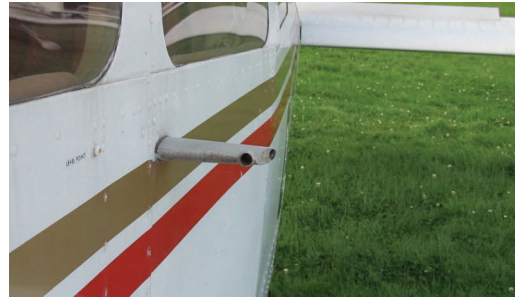
Recently we were reminded that infestation can present problems in other systems. Several Piper Arrows (and probably some similar aircraft) have automatic 'back-up gear extension' systems which automatically lower the undercarriage below a certain airspeed which in the case of the Arrow is detected in a separate pitot/static system on the side of the cockpit. The gear cannot then be raised again until airspeed is increased above another value.

The system is not normally exercised in flight, but it seems that recently an instructor was demonstrating the facility during differences training. Once the system had lowered the undercarriage, it proved impossible to raise it again, despite increasing indicated airspeed. We suspect the pilot decided not to attempt to use the over-ride facility, but preferred to leave the undercarriage in a safe condition.

The culprit was identified as what appear to be insect larvae, and the incident serves as a reminder that a blockage in the main pitot static system, especially if flight cannot be completed by visual reference, can cause serious problems.

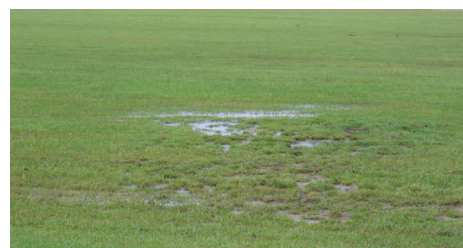
However, as the pilot of a Musketeer apparently found recently, the hazards of wet grass are not restricted to the decrease in take-off and landing performance. It seems that having gathered speed during a downhill taxi, when the pilot attempted to slow down and turn on the wet grass, the aircraft slid sideways into a hedge, causing damage to the wing, fuselage and tail.

It is important to consider the effects on our flight of all the environmental conditions we are likely to experience on a particular day, and make appropriate allowances.

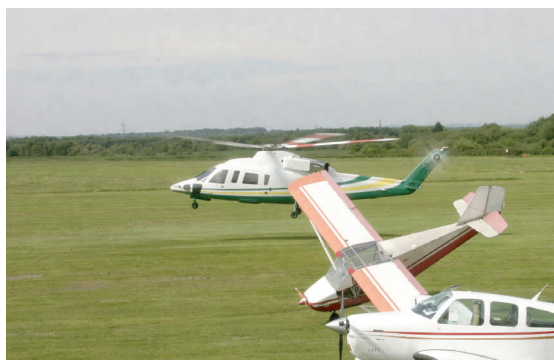
The report in question concerns an AS350 whose commander elected to fly a shortened circuit pattern in order, as he thought, to land before a light aeroplane which he had observed on the downwind leg. It seems he announced his intention on the radio. However, as the helicopter rolled into the final approach, the pilot of a DR400 which he had not seen announced his presence on 'final'. Apparently, the helicopter commander then applied power to accelerate, continuing towards the runway and thereby overflying the aeroplane. As the rotor downwash struck the aeroplane, it was tipped over forcefully onto its wing, and the pilot was unable to regain control before it contacted the ground, causing considerable damage.

Most aeroplane pilots know to avoid flying into rotor downwash or wake vortices. Helicopter pilots must constantly remember that their presence can hazard other aviators, and take all steps to minimise that hazard. However, if we enter a traffic pattern without ensuring we are aware of every other aircraft's position in that pattern, it is very difficult to stay far enough away to avoid causing them problems.

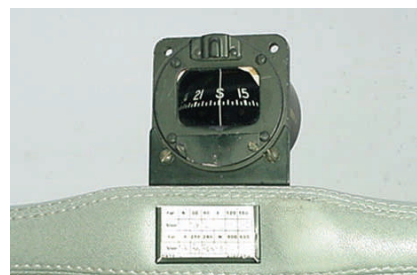
The AAIB report on the Archer ditching referred to elsewhere includes some perhaps unexpected findings about light aircraft compasses. The aircraft apparently experienced an electrical power failure, and the report considers the alternator had been producing no output for some time. The investigation considered the consequences for the aircraft compass.

An aircraft's compass deviation would have been corrected, and the deviation card produced, using compass readings taken with the electrical system and equipment operating normally. With the alternator selected off, or not operating, the compass deviation would differ from when the electrical system was operating normally. A flight trial of a similar aircraft determined that with the alternator selected on and off the compass heading would vary by 12° on a southerly heading and 8° on a westerly heading.

We may occasionally forget that electromagnetic fields produced by any device can and will modify the earth's magnetic field as detected by an aircraft compass. Switching off equipment which was selected ON when the compass was swung, or adding another device in the cockpit, is likely to produce changes in the compass deviation. A fix-point navigation technique, such as that recommended by the Royal Institute of Navigation in their leaflets '[VFR route planning](#)' and '[visual navigation techniques for pilots](#)', free for download from their website www.rin.org.uk >SIGS > GANG>resources, should keep a pilot close enough to his planned track to combat most changes in deviation. However, the error produced by a failed alternator, especially if no check features are available, can be expected to cause significant deviations from planned track. We should bear that in mind when considering our actions in the event of electrical failures.

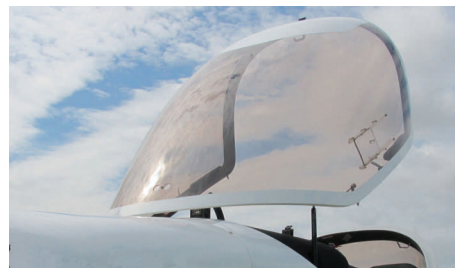
Several modern light aeroplanes have large cockpit canopies which are hinged at the front and latched at the rear. This arrangement would appear to reduce the risk of damaging the structure if the canopy were to unlatch in flight. However, the shape of such canopies is usually that of a three-dimensional convex curve, similar in an exaggerated form to the shape of the upper surface of a wing. If the latch at the rear of the canopy comes open in flight, the 'bernouilli effect' of the air flowing over the canopy will attempt to 'suck' the canopy open and hold it in a position well above the rest of the aircraft structure, possibly beyond the reach of the pilot if he were to attempt to close it again.

The air flowing over such an open canopy would interact with the slower moving air in the lee of it, generating turbulence resulting in drag. That drag may be sufficient to overcome the thrust available from the engine, forcing the aircraft to descend in order to maintain a safe airspeed, as the pilots of two separate aircraft involved in accidents reported in the AAIB Bulletin 10 of 2012 discovered. We should all be aware of the need to pay particular attention to the condition of our latches and to the security of our canopy before take-off. However, since air turbulence has been reported as the instigator of some unlatching events, we must also be aware of, and remain within, the manufacturer's recommended airspeeds for flight in turbulence.
