# Aviation Investigation Preliminary Report

<b>Location:</b>	Jersey City, NJ	<b>Accident Number:</b>	ERA25MA171
<b>Date &amp; Time:</b>	April 10, 2025, 15:15 Local	<b>Registration:</b>	N216MH
<b>Aircraft:</b>	Bell 206L-4	<b>Injuries:</b>	6 Fatal
<b>Flight Conducted Under:</b>	Part 91: General aviation - Aerial observation

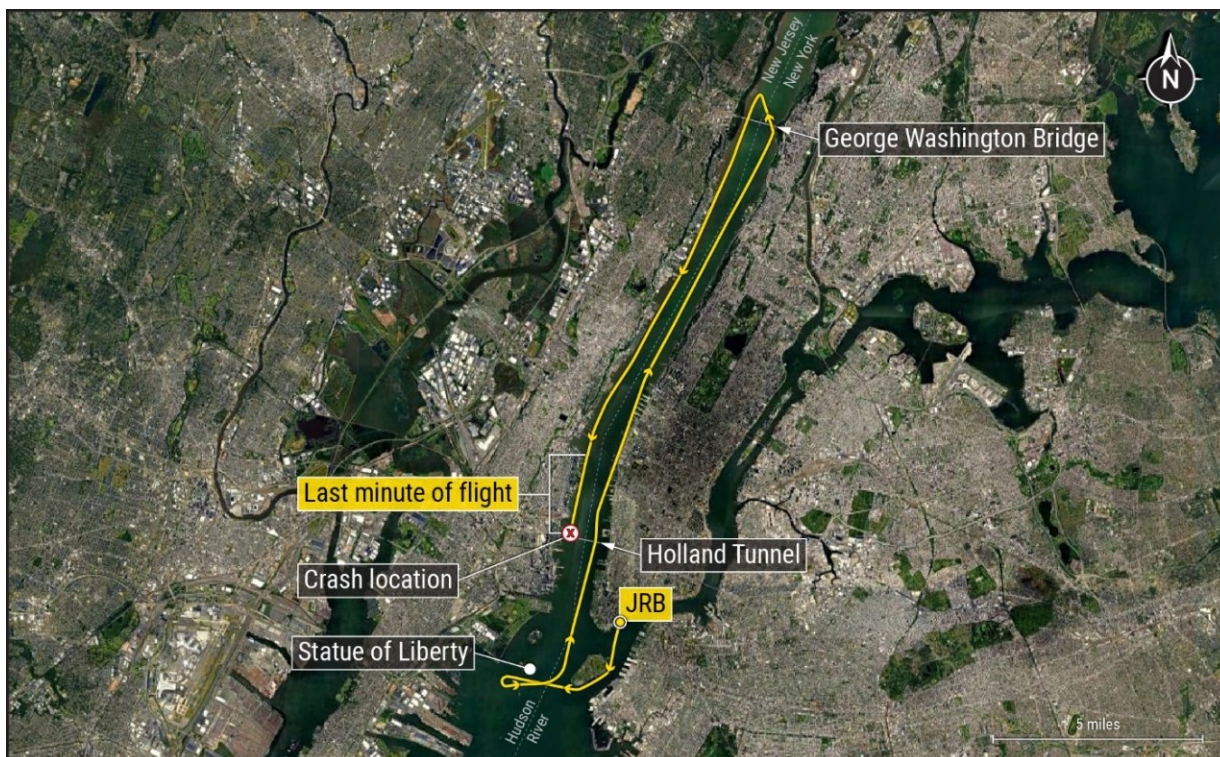
Preliminary Automatic Dependent Surveillance-Broadcast (ADS-B) flight track data obtained from the Federal Aviation Administration (FAA) revealed the helicopter departed Downtown Manhattan/Wall Street Heliport (JRB), New York, New York, about 1458. The helicopter flew a teardrop pattern south of the Statue of Liberty, then proceeded north along the east side of the Hudson River adjacent to Manhattan, past the George Washington Bridge, where it performed a u-turn, then headed south along the New Jersey side of the river (figure. 1).

**Figure 1. ADS-B flight track overview of entire route of flight from takeoff through loss of signal near the accident location.**

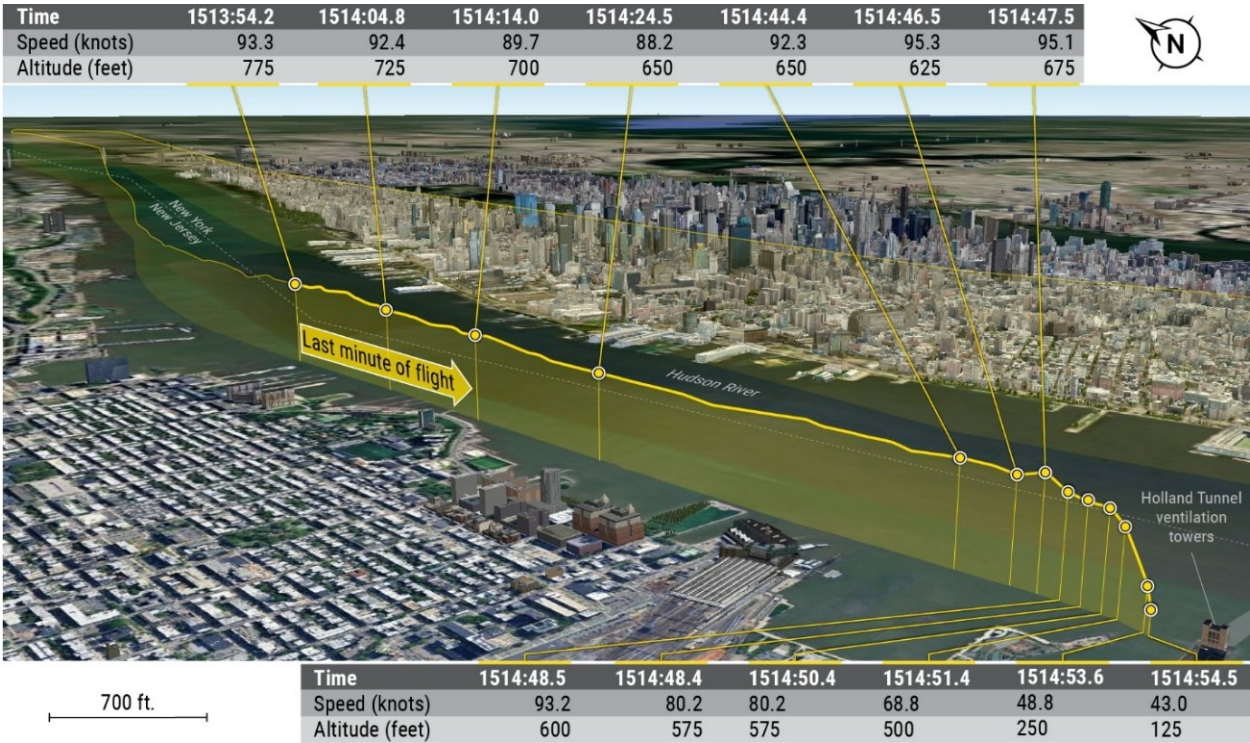
Figure 2 depicts the plot of the helicopter's ADS-B-observed flight path for the final 1 minute of flight, with the reported time, altitude and groundspeed superimposed. As the helicopter approached the Holland Tunnel ventilation towers near Jersey City, New Jersey, it was at a geometric altitude between 625 and 650 ft. The helicopter's altitude increased to 675 ft msl

before it entered a rapid descent. The data ended at 1514:54.5 and the helicopter’s last observed altitude was 125 ft.

**Figure 2. ADS-B flight track and geographic data highlighting the last minute of the flight through breakup, uncontrolled decent and loss of signal.**

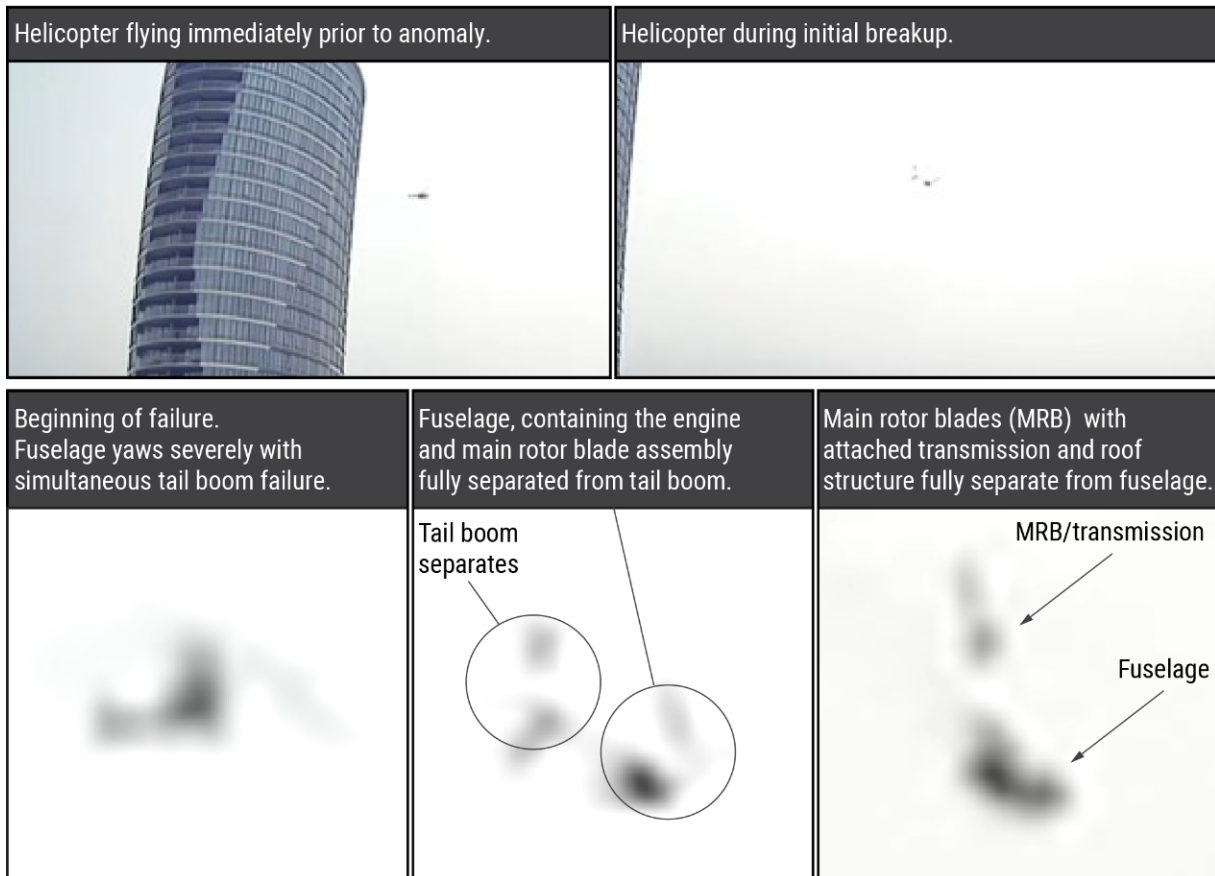
Several witnesses described hearing several loud “bangs” emanating from the helicopter before it broke up and descended into the river. Surveillance video (with accompanying audio) captured the helicopter traveling south before it suddenly separated into three major sections: fuselage (including the engine), main rotor system (including both main rotor blades, transmission and roof-beam structure), and the tail boom (including the tail rotor) (figure 3).

**Figure 3. Enhanced surveillance video with sequential images depicting the helicopter's flight and breakup.**
